PROCEED ORDER

The Journal of the Signalling Interest Group Queensland

No.11

July/September 2021

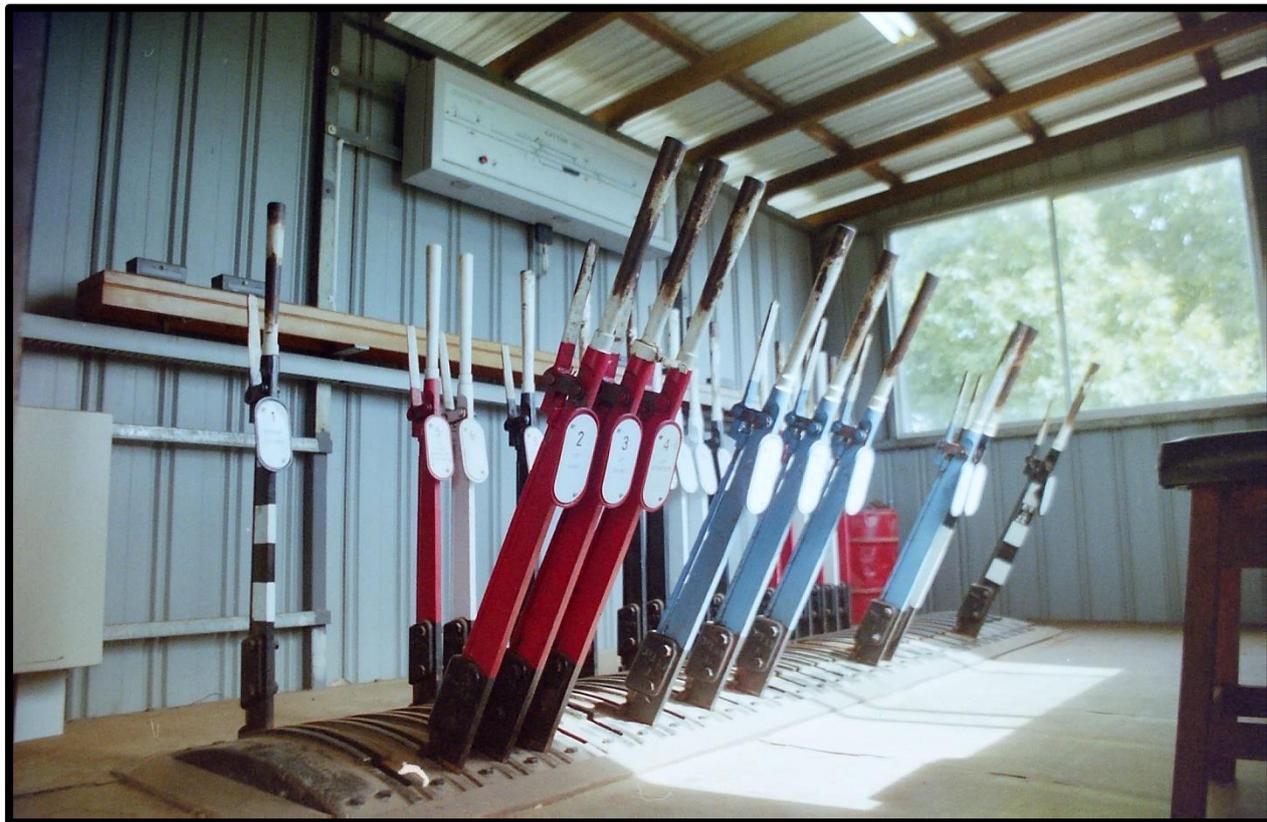
The lever frame in Gatton signal cabin, cut in due to Single Line Working in April 2002. The Down Electric Release has been taken and all Down signals placed at 'stop'. The Up Electric Release (lever No.1) is not taken and the Up signal levers are all at 'proceed'. The cabin has since been decommissioned and removed. The lever frame was known to exist in a private collection and the cabin diagram in a different private collection.

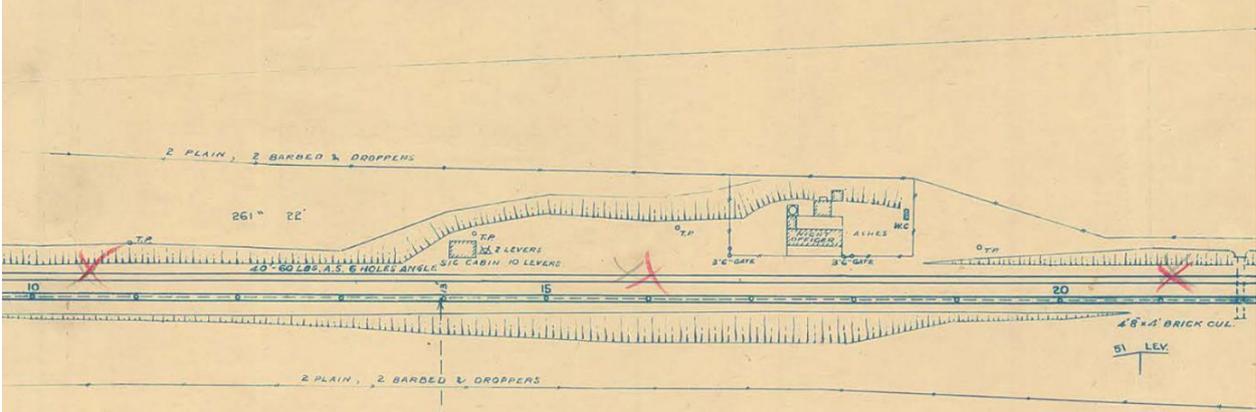
The signal cabin itself was near the centre of the crossing loop on the southern side of the line; outside the cabin at the Toowoomba end were two additional signal levers which were used when the cabin was cut-out. The concrete foundation of the signal cabin was about 16 feet 4 inches long, 11 feet 4 inches wide, which gives the approximate size of the building. The foundation also shows the position of the lever frame

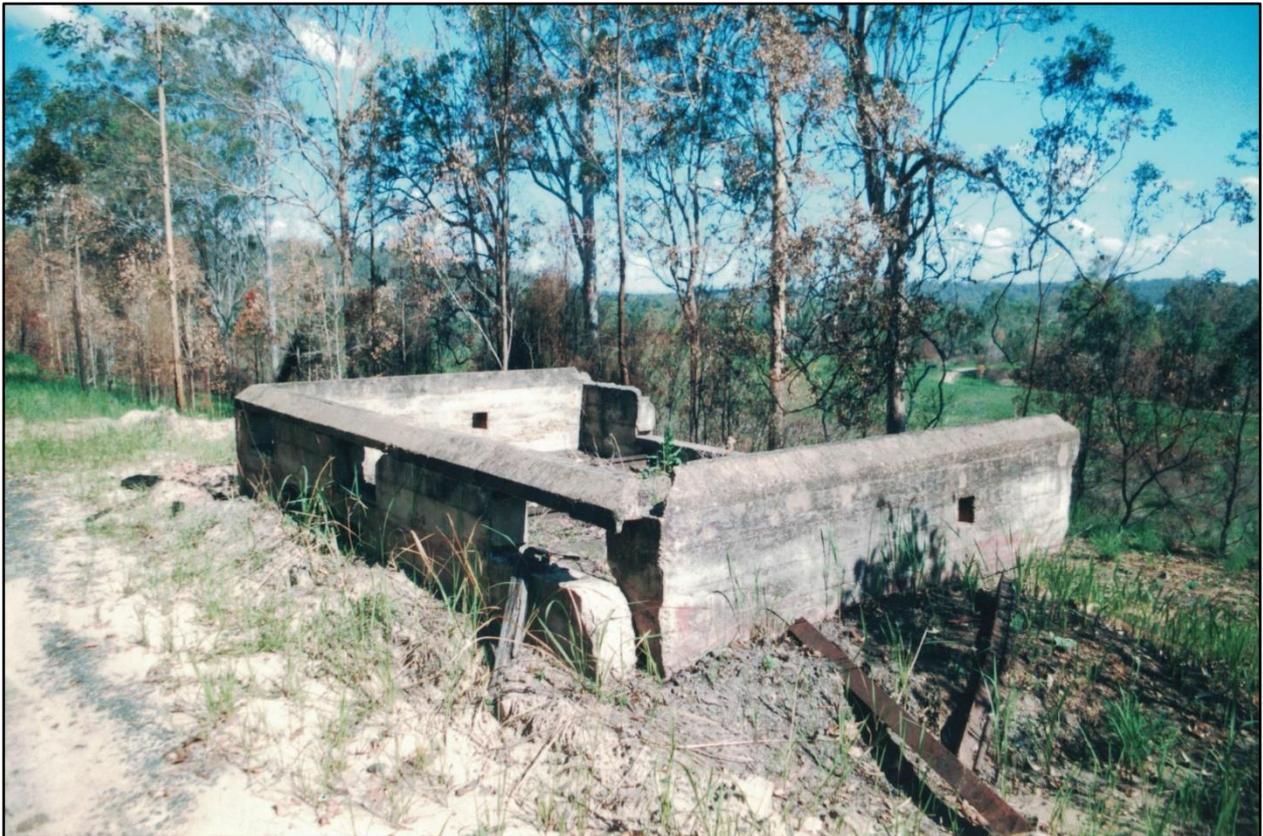
Above: The remains of the foundation for Magoon cabin. The cleared area behind the cabin would have been bushland in the 1940's.

within the building near the Brisbane end. Two rails were positioned here to accommodate the 10-lever interlocking machine which operated the two sets of points and six signals provided. The rails were spaced at approximately 4 feet 2 inches which suggests a lever frame with 5" centres between levers was used. The use of these rails also indicated that a low-level lever frame was used which indicates the building was not a tall one, and that the signalman faced away from the tracks when operating the levers. No photographs are known to exist of Magoon signal cabin but I have a feeling that it would have been a quite typical Type 1 signal cabin.

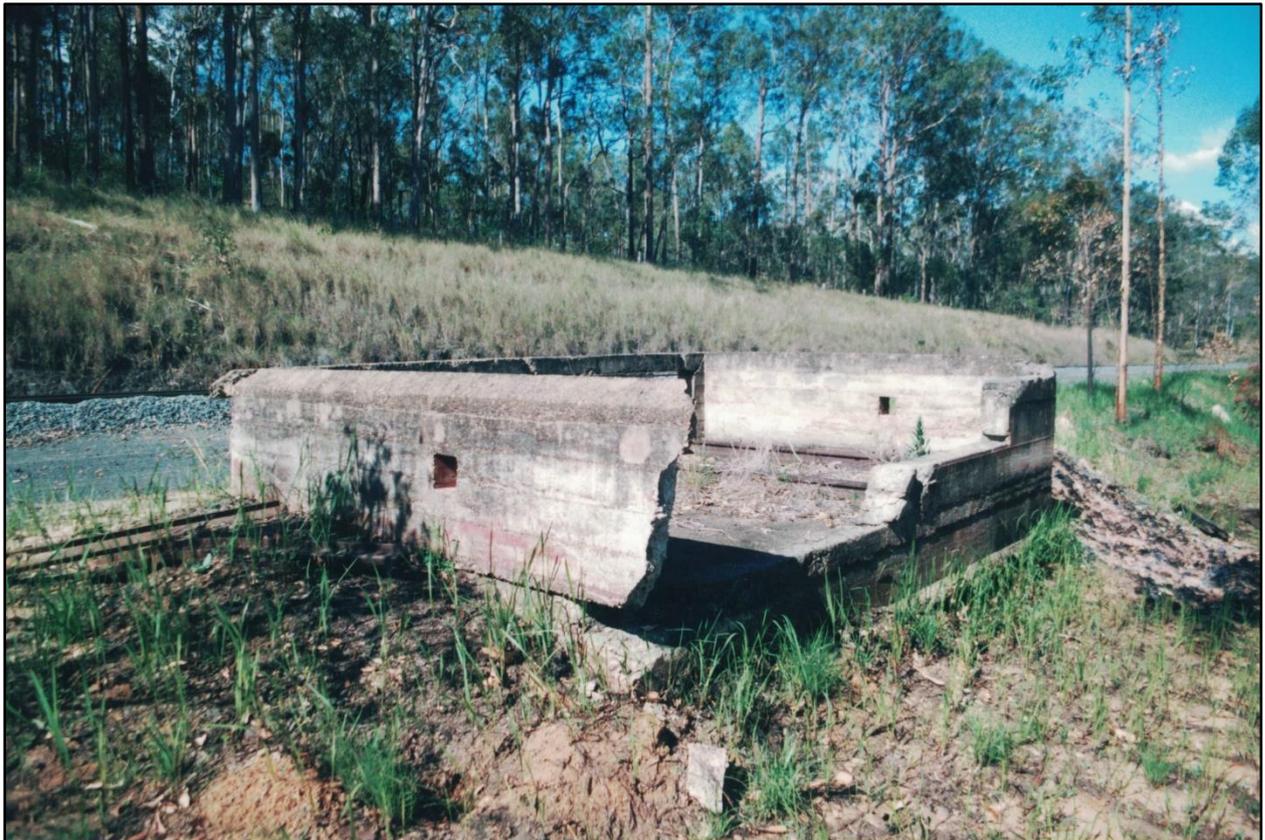
Above: Another view of the foundation of Magoon cabin, the location of the lever frame is evident.
