# PROCEED ORDER

The Journal of the Signalling Interest Group Queensland

January/March 2020

# Bluff's Interlocking Machines

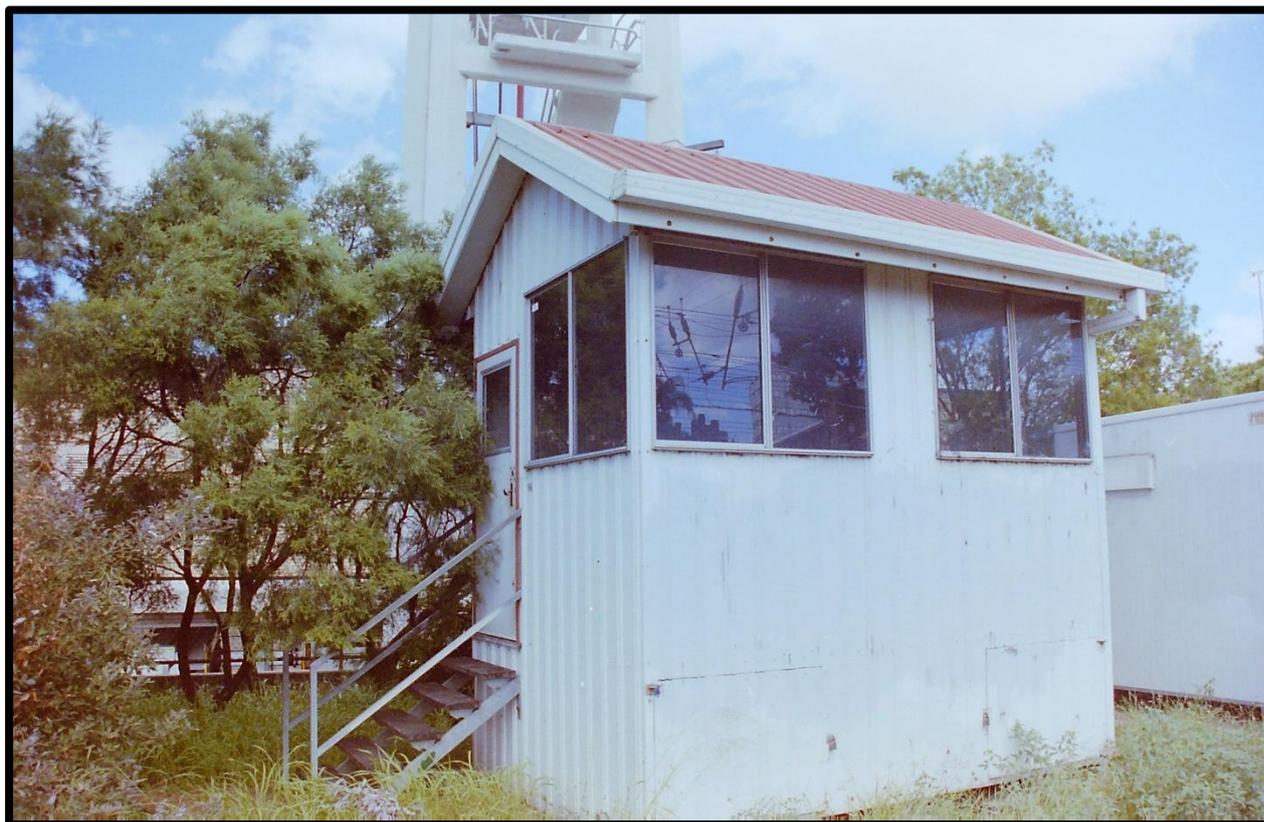
*The small signal cabin at Roma Street which controlled shunting movements within the Standard Gauge lines at Roma Street. Inside there was a 10-lever low-level interlocking machine with duplex tappet interlocking. The signal cabin was placed out of use and was removed on the 10th of September 2006 for preservation by an enthusiast group.*

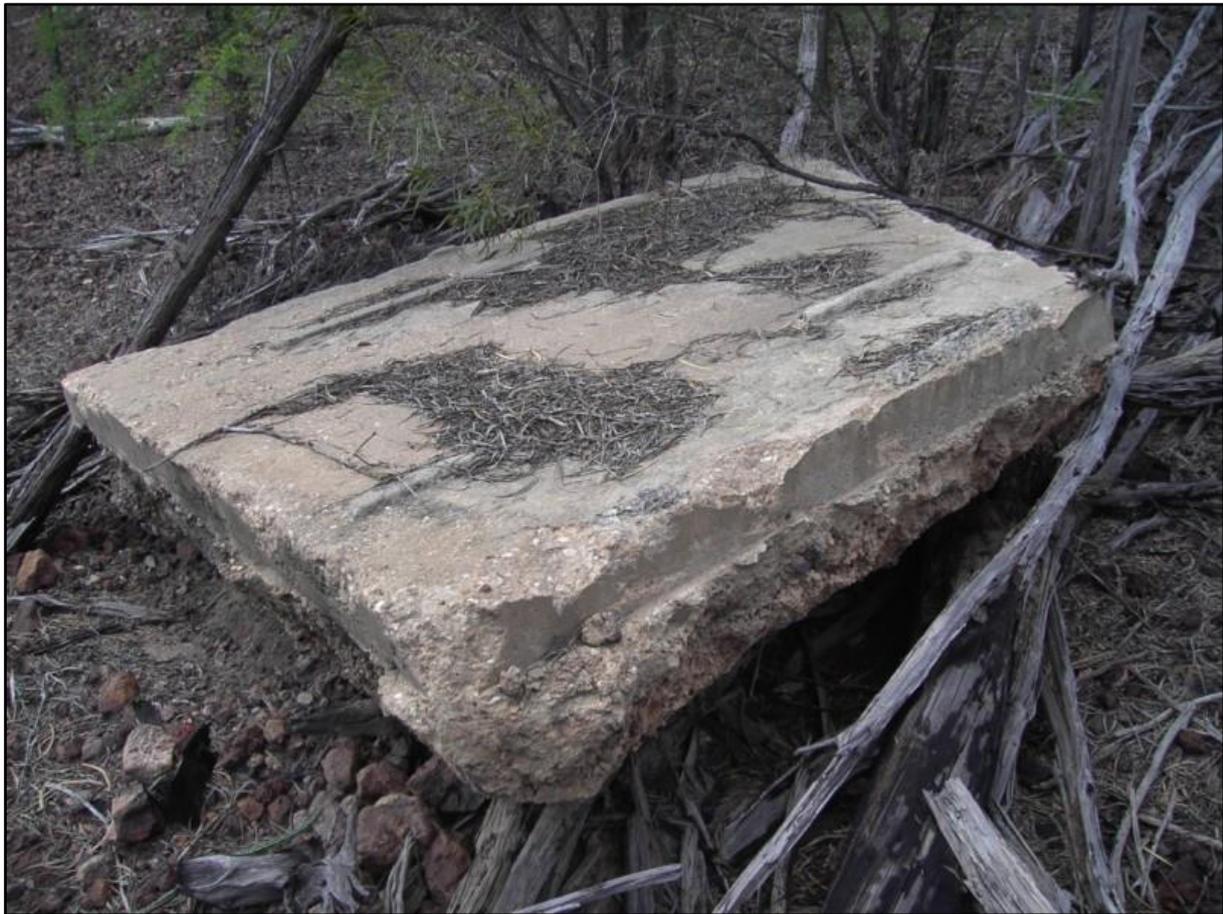
*Photo 1: The large piece of the concrete foundation showing the two ridges of concrete running lengthwise.*

The first piece of evidence discovered was the large piece of the concrete foundation as shown in Photo 1. It had been dug out of the ground and pushed away from the railway corridor a short distance and is now outside the railway corridor on the southern side of the line.

The concrete foundation is seven feet ten inches wide and about the same length however the top edge is broken off at an angle. Running lengthwise along the foundation are two raised ridges of concrete spaced four feet four inches apart. Near the unbroken corners of the foundation are bolts which have been cut off and a third cut off bolt exists along the side of the foundation near the broken edge.

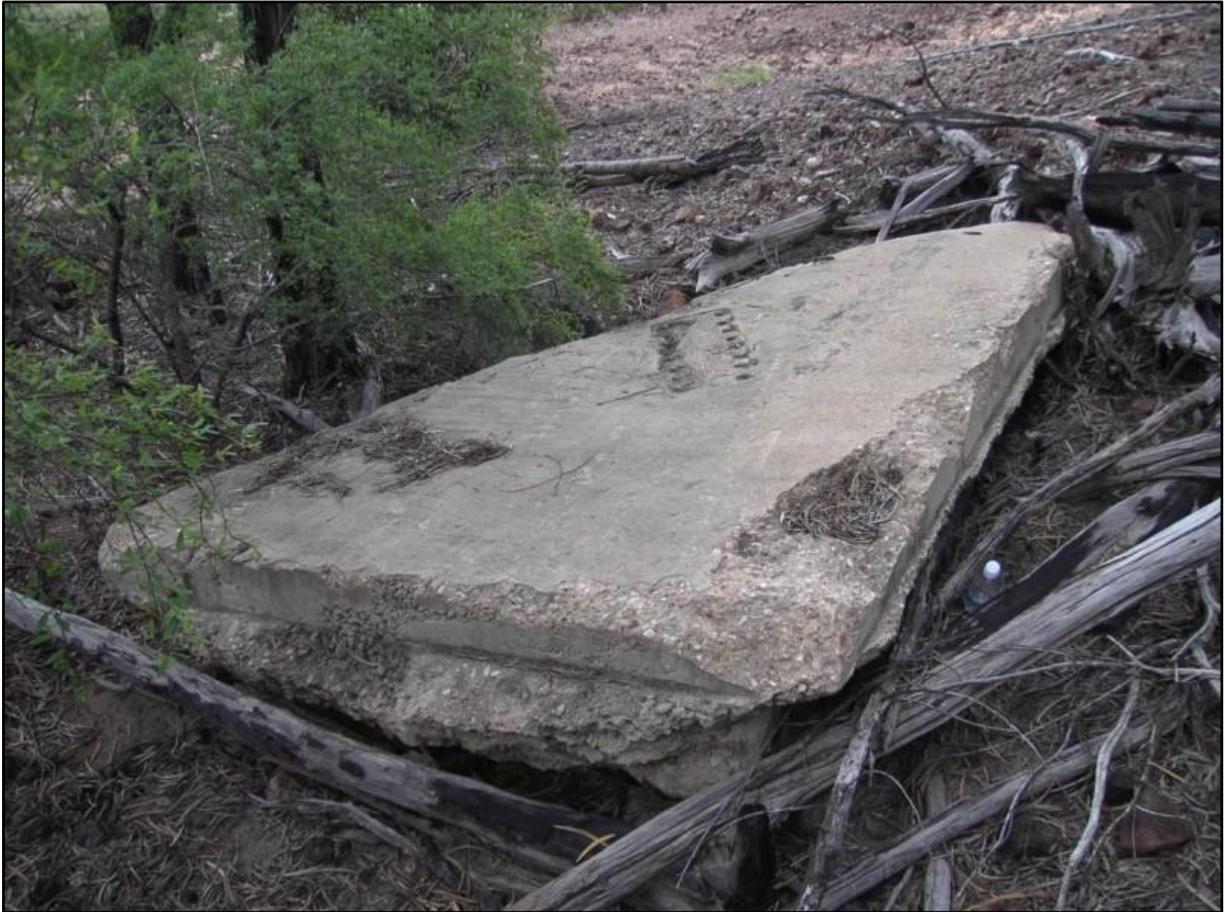
*Photo 2: The smaller piece of the foundation which was broken from the larger piece.*

The second piece of evidence discovered was the smaller triangular piece of the concrete foundation as shown in Photo 2. It also measures seven feet ten inches wide and about five feet long on the straight unbroken

side. Studying both pieces revealed that the smaller piece was indeed the corner which was broken off the larger piece during removal. Adding the measurements of both pieces reveals that the concrete foundation measured about seven feet ten inches wide by twelve feet ten inches long.

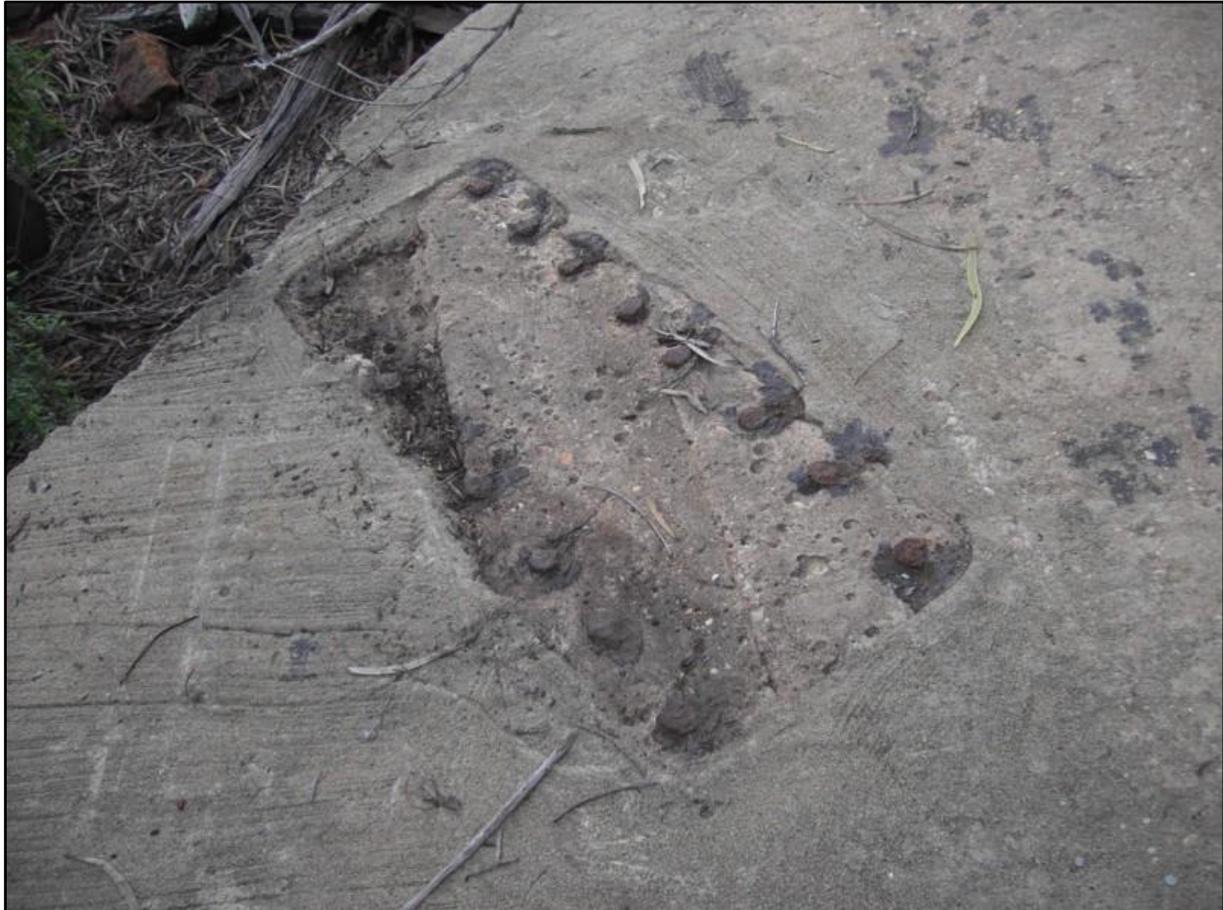
*Photo 3: The sixteen cut off bolts where the four Accommodation Cranks were bolted clearly indicated the concrete was part of a signalling system.*

The key thing to note, as shown in detail in Photo 3, are the sixteen cut off bolts placed in a very unique layout, near the middle of the long broken edge on the smaller piece of concrete. The layout of these bolts confirmed that these remains were part of a railway signalling structure. These sixteen bolts would have secured the Accommodation Cranks in position with each crank requiring four bolts. The Accommodation Cranks are where the point rodding, exiting a signal cabin perpendicular to the track, turns through 90 degrees to run parallel to the track towards the points operated from the cabin. This evidence shows that at least four point rods, hence four levers, could have been provided.

inches. The Accommodation Cranks are 90-degree cranks and have arms which are ten inches in length. By measuring the horizontal distance between the Accommodation crank centres it can be determined that the levers they connected to were spaced at five-inch centres in this case.

The distance from the edge of the slab to the centre of the first Accommodation Crank is three feet four inches or 40 inches, and the distance from the same concrete edge to the raised frame support is one foot nine inches or 21 inches. By drawing this to scale on the attached diagram the position of the ten-inch cranks, point rods and ends of the lever frame can be clearly seen.

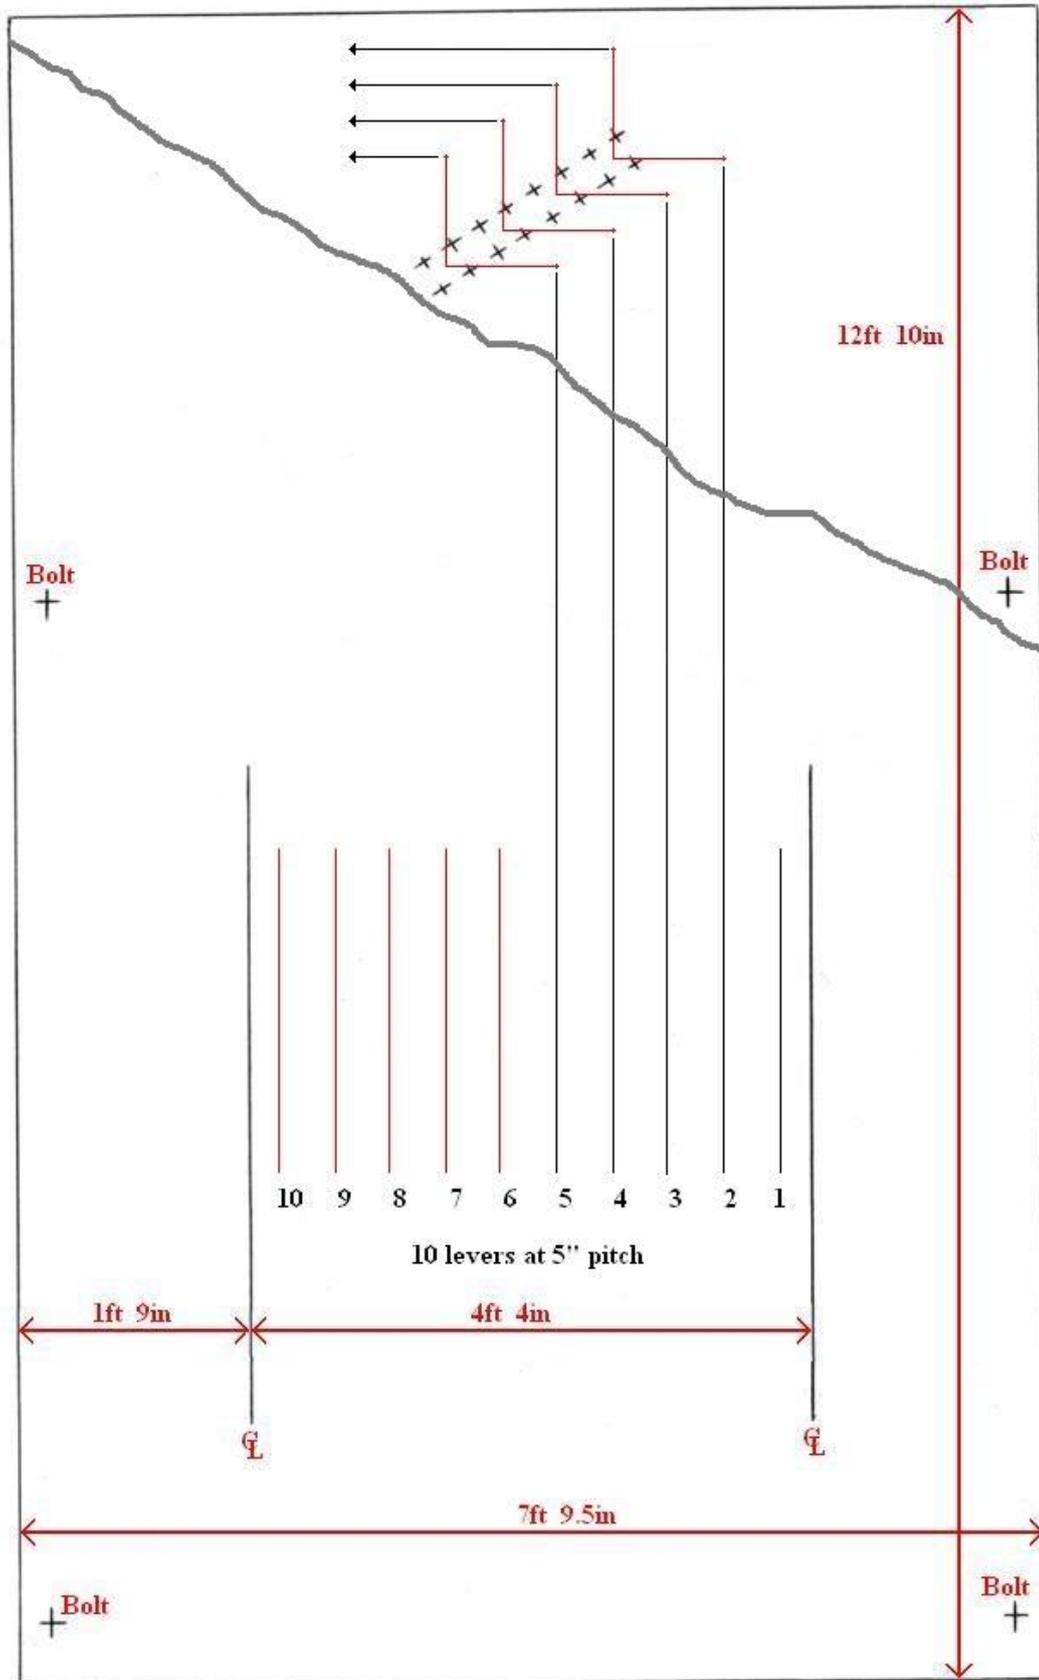
*Drawing 1: A scale drawing showing the layout of the foundation and the positions of key elements.*

By continuing this five-inch spacing it can be seen that five more rods are possible to the left, and one more rod is possible to the right. In total ten levers at five-inch pitch can be neatly spaced between the ends of the lever frame.

The next question is are these levers 6-9 with the signalman facing the track, or levers 2-5 with the signalman facing away from the track. Similar lever frames at Warwick, Kaili, Pring, Callemondah and Mackay all have the signalman facing away from the track. It is also unlikely that levers 1-5 were signals so it is presumed that the signalman faced away from the track and that the point rodding was connected to levers 2 to 5. Lever 1 was quite possibly a Release lever but this is impossible to determine from the remains. Likewise, it is also impossible to determine what levers 6-10 were used for or indeed if they were even installed. Warwick B frame had a capacity for 10 levers but not all the levers were installed with empty spaces left where they could be added if required later.

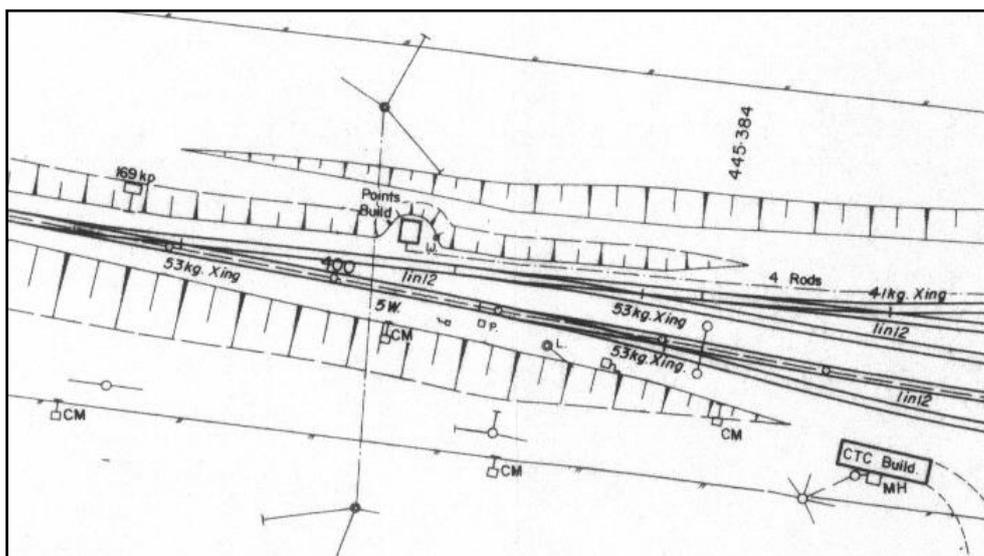
*Part of Plan C3232 showing the location of Bluff east lever frame.*

At this point I made a visit to The Workshops Museum at Ipswich and asked for any station yard plans for Bluff. I have looked at these previously and did not find any mention of such a signalling structure existing. A few plans did exist, but they did not help solve the problem of identifying this lever frame. Another station yard plan had recently been donated to The Workshops Museum and it showed the track layout at Bluff after the implementation of CTC signalling. The plan is numbered C3232 and is dated 14-5-1985.

While these plans typically deal with track layout and buildings they sometimes show some details of signals and signalling equipment. This was indeed the case with this plan as it shows a lever frame at both the eastern end and western end of Bluff yard allowing access to the 4th and 5th roads as I deduced above. Further, the plan shows the route taken by the point rodding and states at the eastern end that "4 rods" run beside the track, fully supporting my theory. The location of the structure is marked as "Points Build" meaning points building. Interestingly the western end of the station yard plan states "Pts Cabin" and "5 rods" beside the track and the reason is that an additional small loop siding existed at the western end of Bluff yard, behind the 5th road, and was also operated from the west cabin.

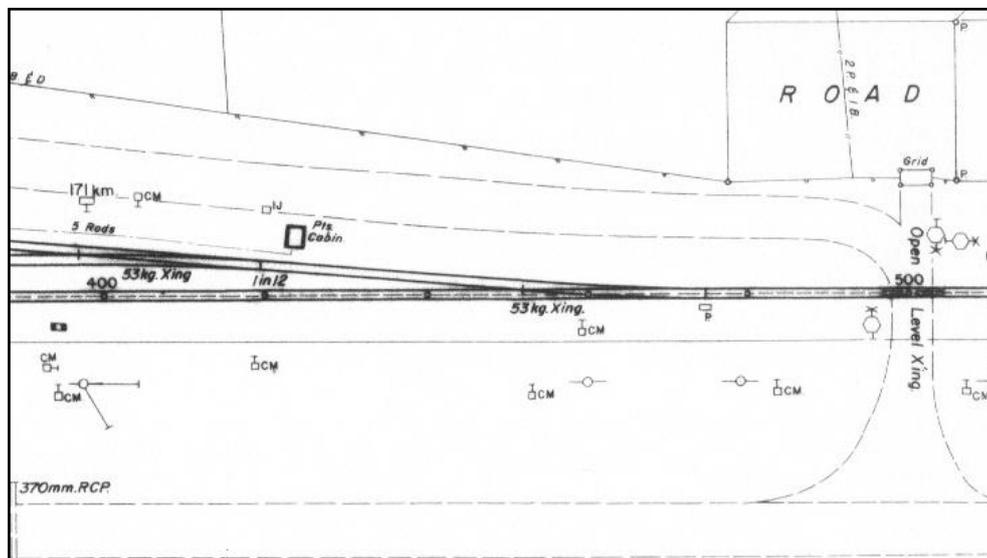
Part of Plan C3232 showing the location of Bluff west lever frame.

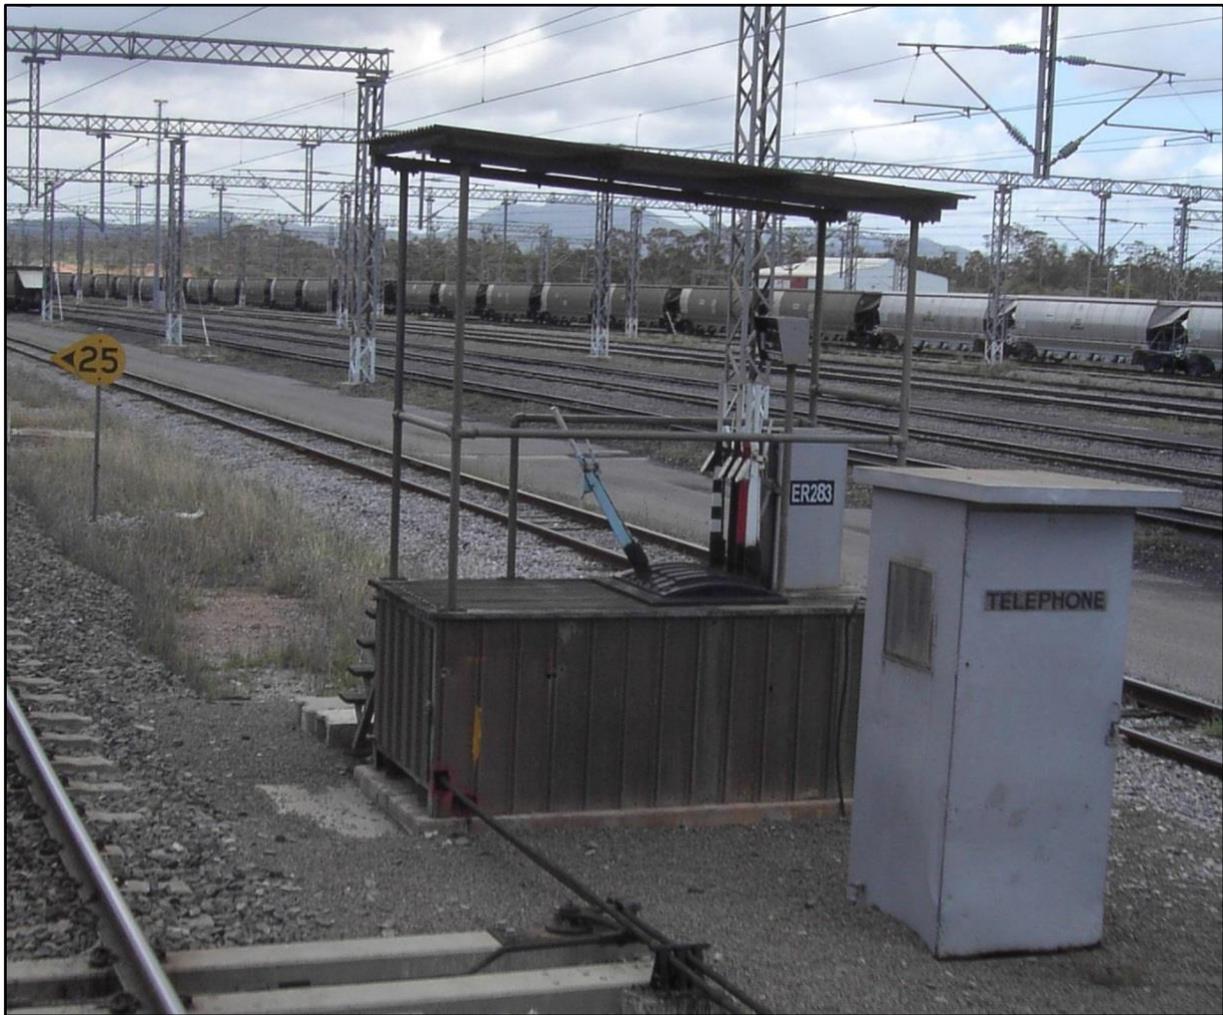
*Photo 4: A similar structure to what existed at Bluff, but with a capacity of 5 levers instead of 10 levers.*

The last question was to find out what happened to the similar concrete foundation which supported the lever frame at the Western end of the yard. Several walks around that area failed to find any remains and it was initially suspected that the concrete may have been left in the ground and buried under ballast when the track was duplicated westwards towards Boonal. Finally, another walk around a different part of the eastern end of Bluff yard yielded a large piece of concrete sitting vertical against a tree and surrounded in very tall grass. A quick observation of the concrete slab revealed that it was the foundation for the Bluff west lever frame which had been removed and dumped at the opposite end of the yard. The concrete foundation for the Bluff west lever frame had 20 cut off bolts also proving that five Accommodation Cranks, hence five point rods were provided.
